National Register of Historic Places Registration Form

historic name Thornton

other names K-195

K-195
Thornton

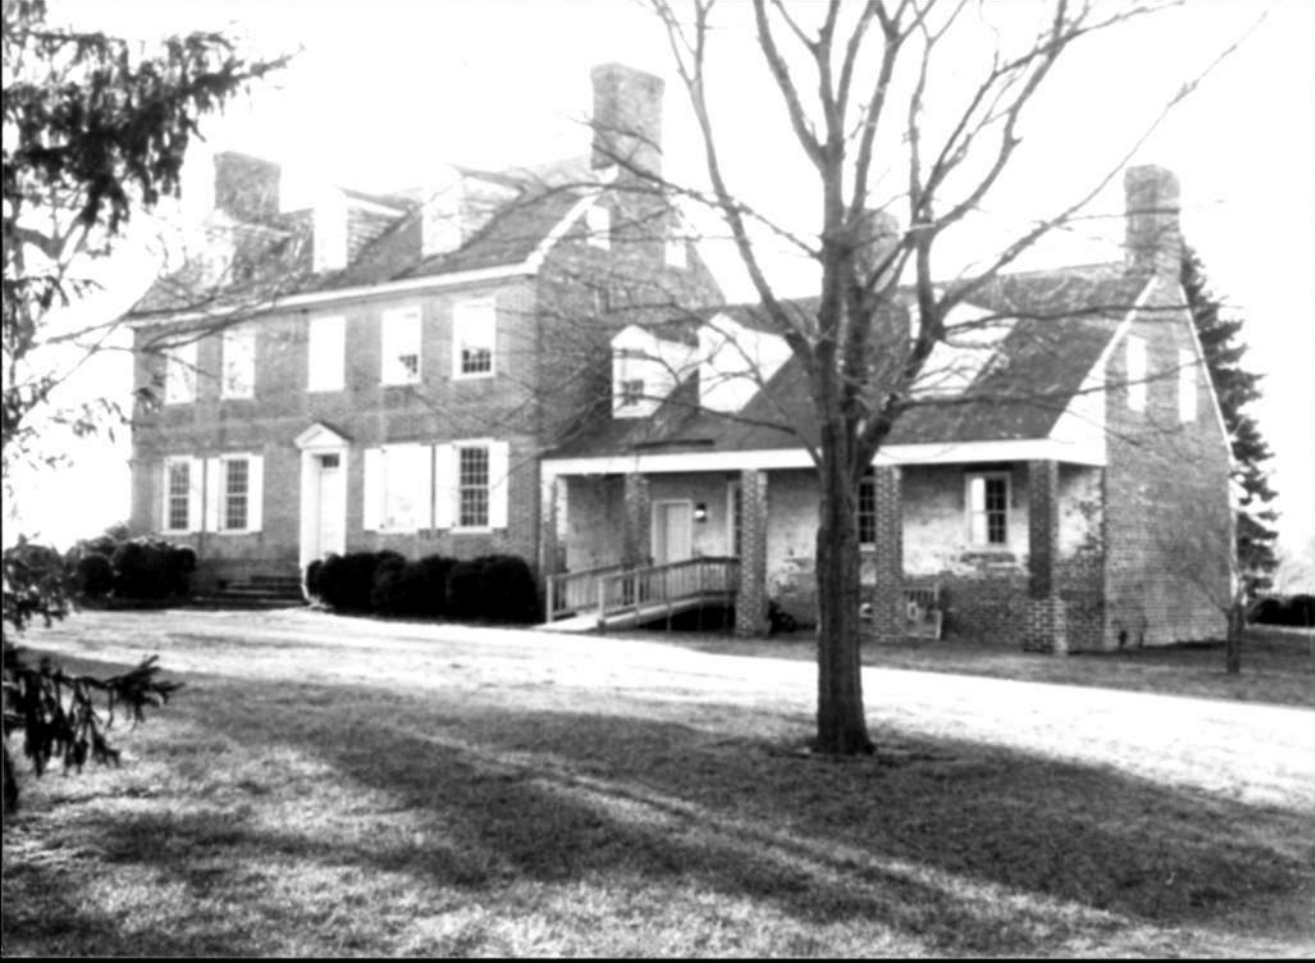
1 of 18

Main house, view to southeast

Thornton is a brick house and wing built in the late 18th century. It is located on Perkins Hill Road near Urieville and faces north across open fields. The main house is five bays wide and two and one-half stories high standing on a tall basement which is marked with a molded water table. The gable roof of the main house has two gable dormers in each roof slope. The chimneys are enclosed in gable walls and have corbelled and banded brick caps.

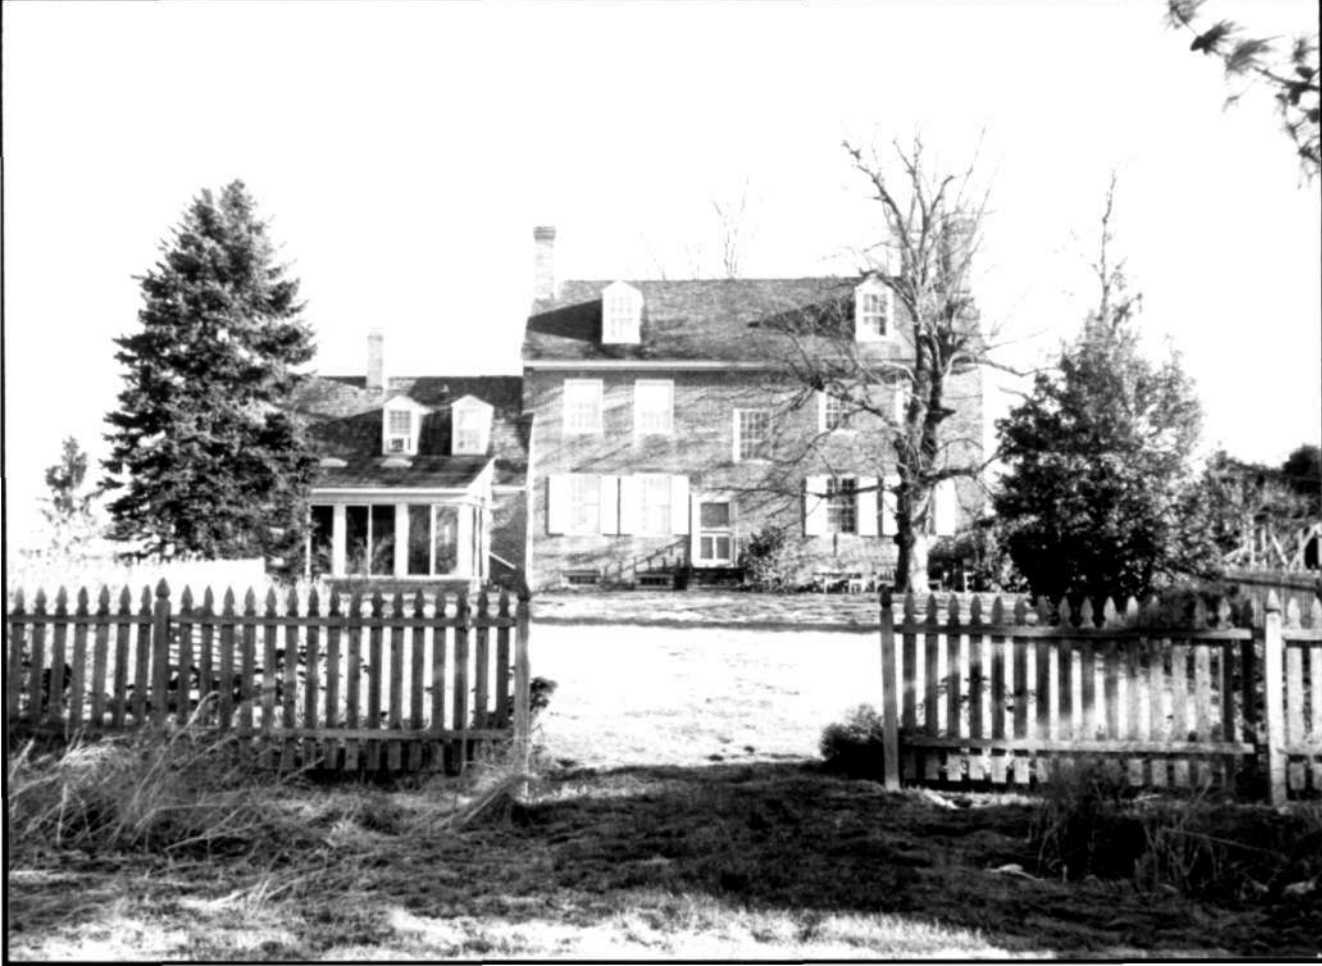
Zg18

Main house, view to north

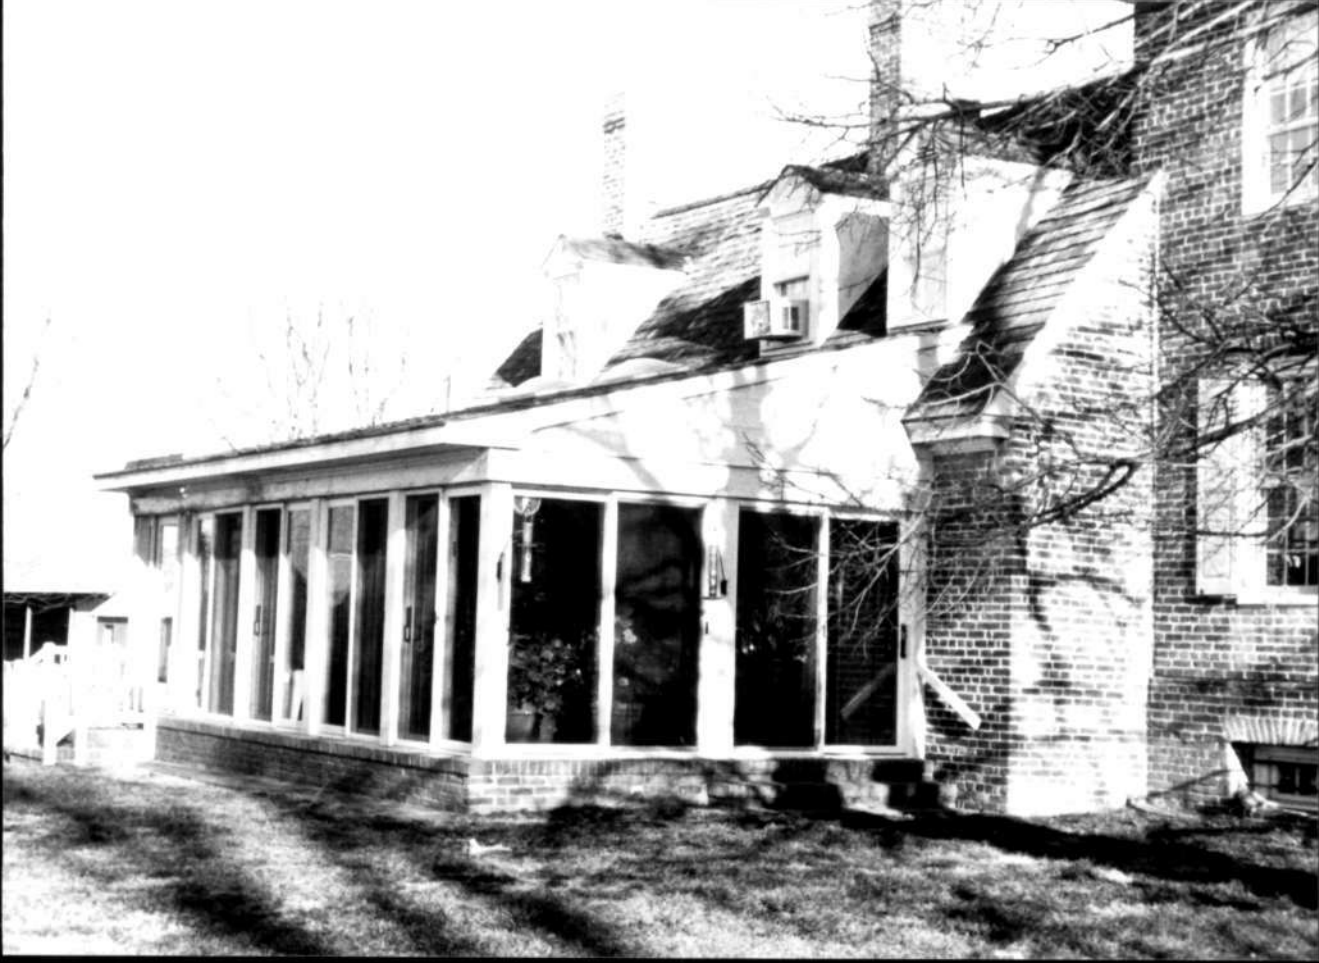
4g18

Mainhouse, porch addition, view to NW

Rehabilitation: In the 1980s the house was rehabilitated for modern use. All of the fireplace flues were rebuilt, one chimney stack was shortened to its original height. The interior wood work on the second floor bedrooms was re-installed to full-depth closet space. A false wall was installed in the stair hall to hide utility service to the second floor, which included installation of a full bathroom in the hallway. Nineteenth century elements, including Victorian second story shutters and hardware, and remnants of a Victorian porch on the facade were removed. Although a reproduction porch entablature was added that followed the ghost of the original pediment, the surviving pilasters were retained. Modern utilities were installed and a new wood shingle roof was laid. A porch was added to the kitchen wing.

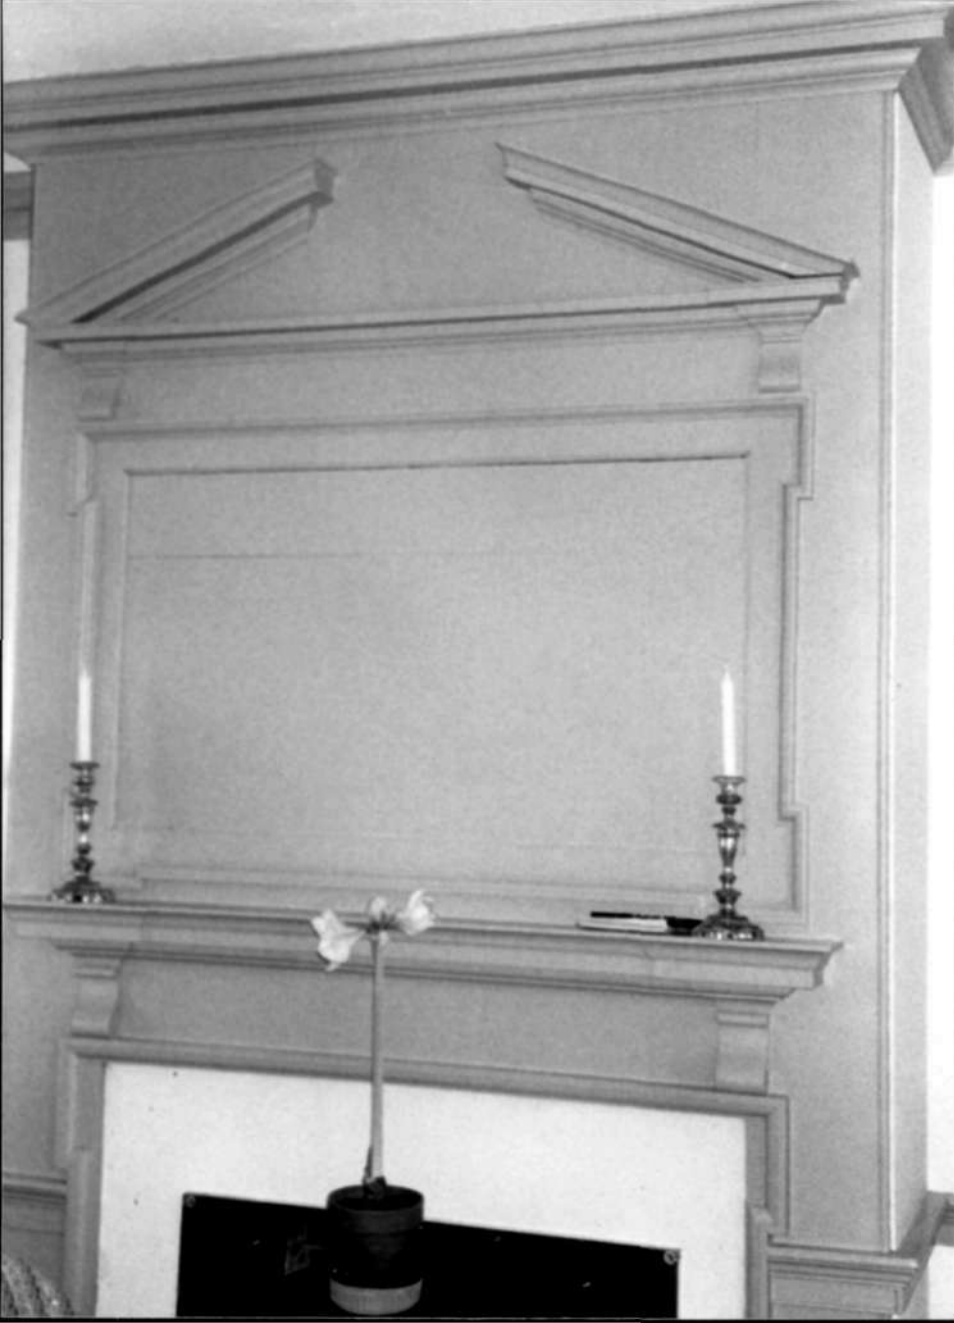
5g18

Main house, Parlor mantle

In the main, East parlor, the fireplace has a tabernacle overmantel. The fireplace opening is rectangular with quarterround crossette surround. The straight mantel shelf has a curved bracket support. The room has crossette trim on the four windows and the door.

The mantel has mahogany graining with black picking-out on ogee edge of panels. Panel fields are oak burl. Six-panel doors have oak graining with burl panels.

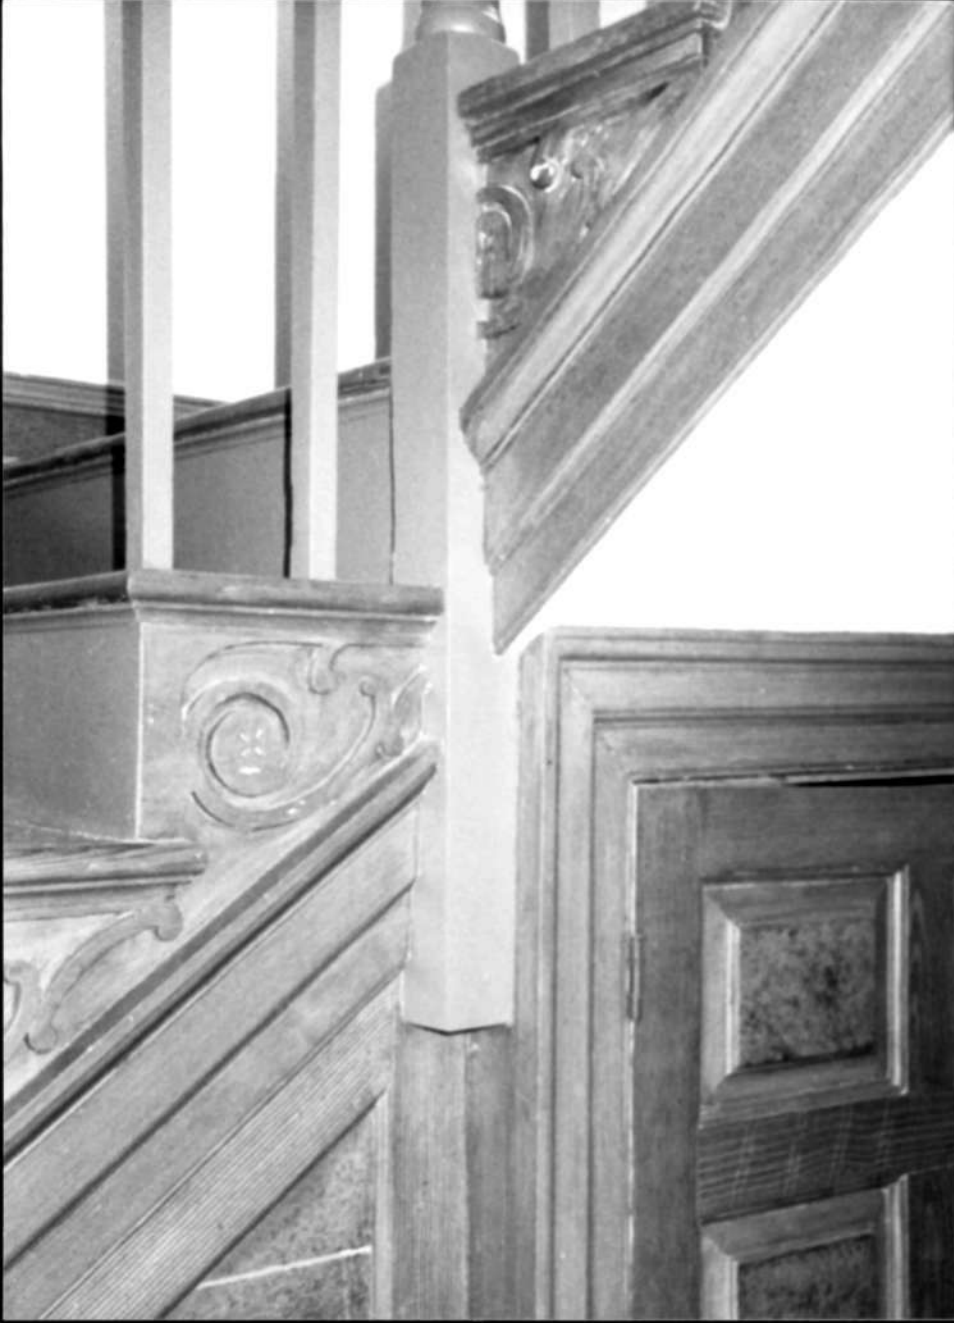
6 of 18

Mainhouse, stairhall detail

The stair is of the three run type and is open to the attic. The newel is very simple and turned as are intermediates. The newel cap is continuous with an oval, molded handrail. Balusters are rectangular, two per step. Step brackets have a scroll design up to the second floor and a curved slot above that. The spandrel is a simple rectangular panel with painted maple burl graining.

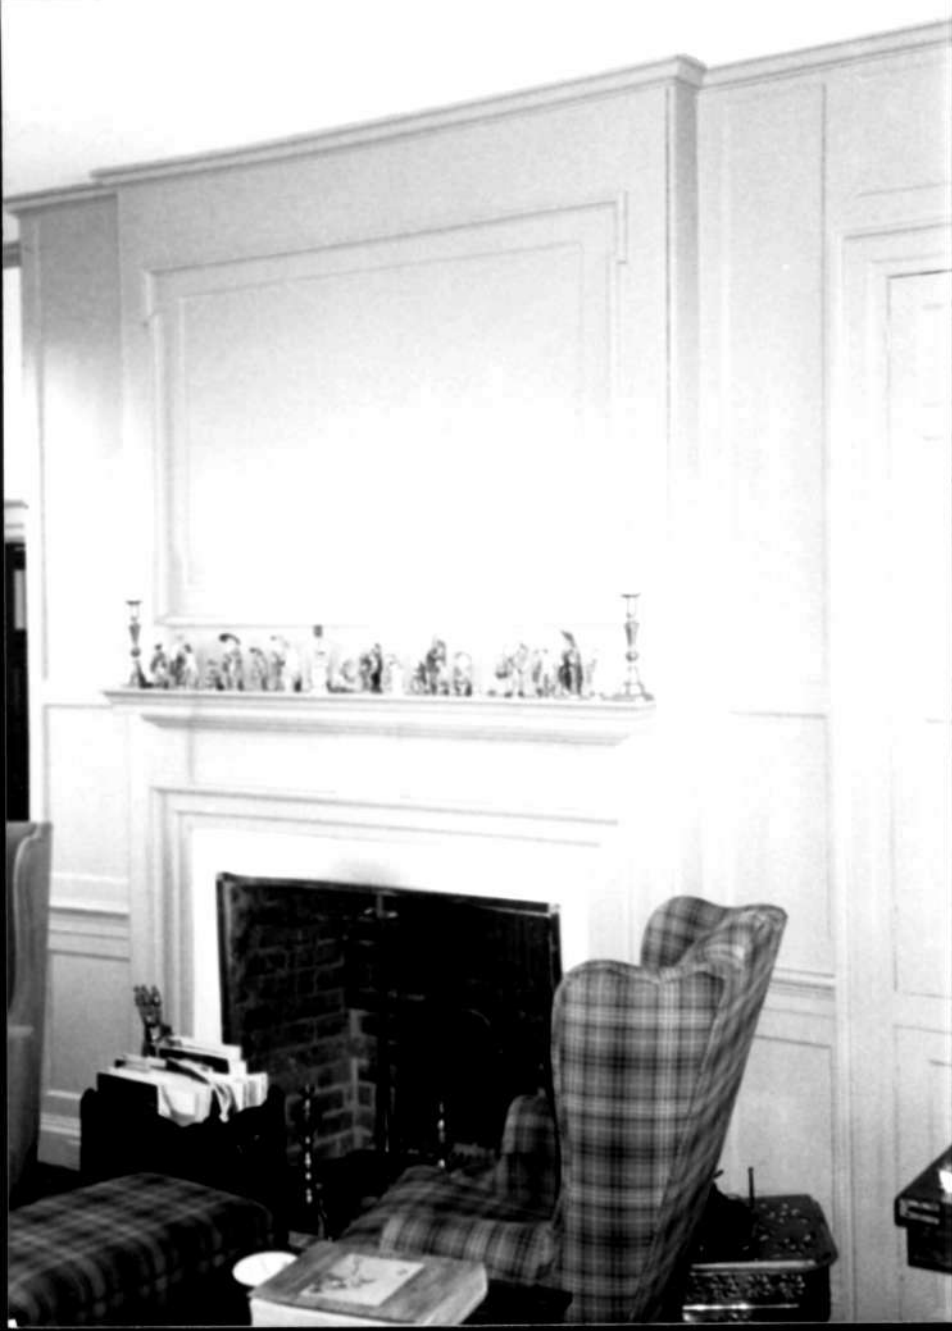
7g18

Main house, Library mantle

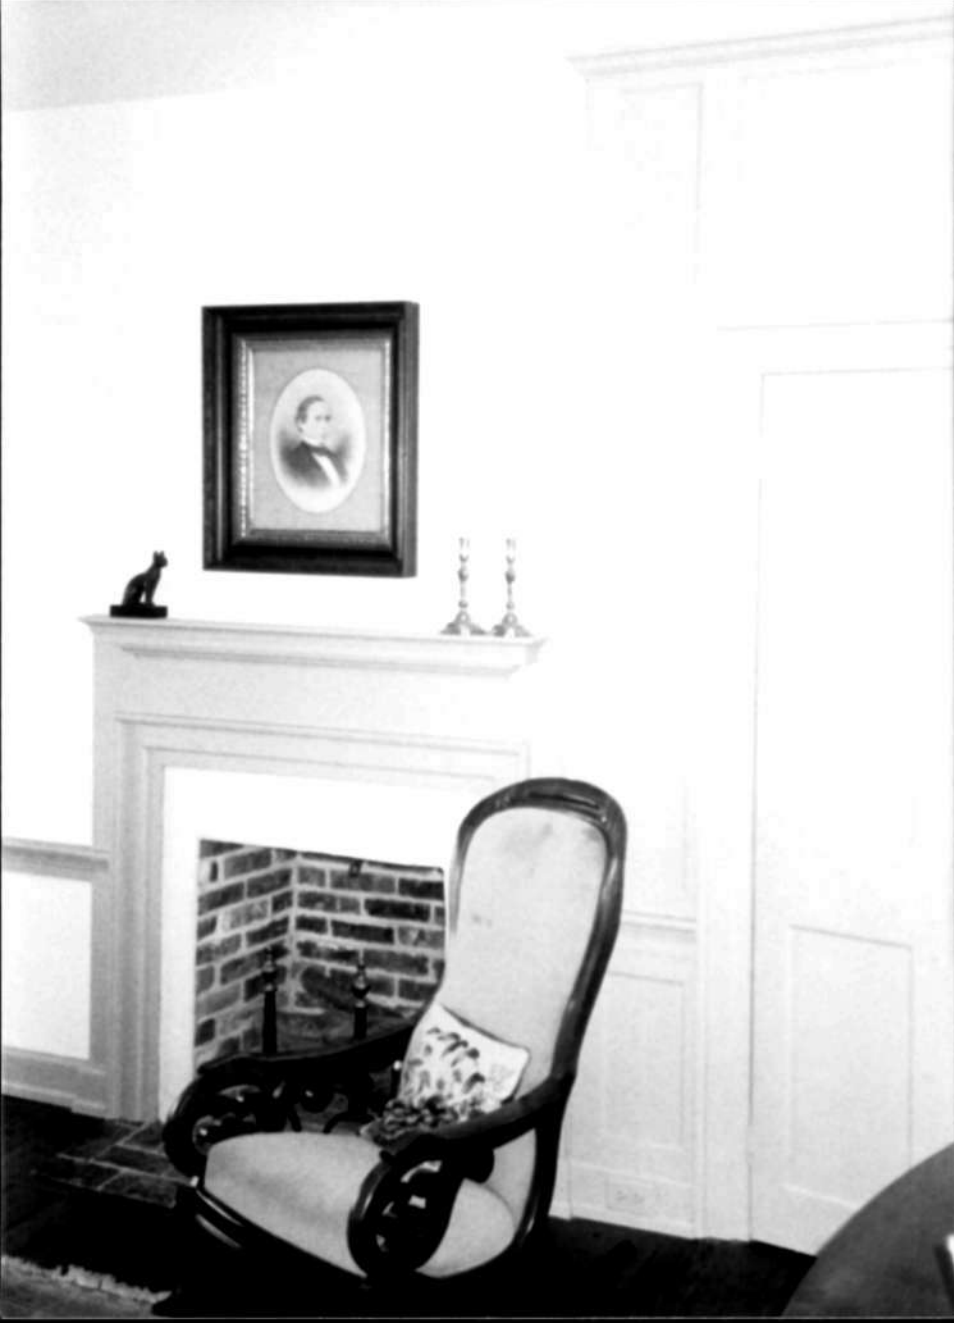
9/18

Main house, upstairs bedroom
mantle

The parlor chamber has a mantel with shelf supported by brackets and two flanking closets with six-panel doors. Paneling on this wall is recessed; the same chairrail as above is used but the window trim is a single quarterround. The west room on the second floor has a very similar paneled fireplace wall but the mantel shelf is supported by consoles.

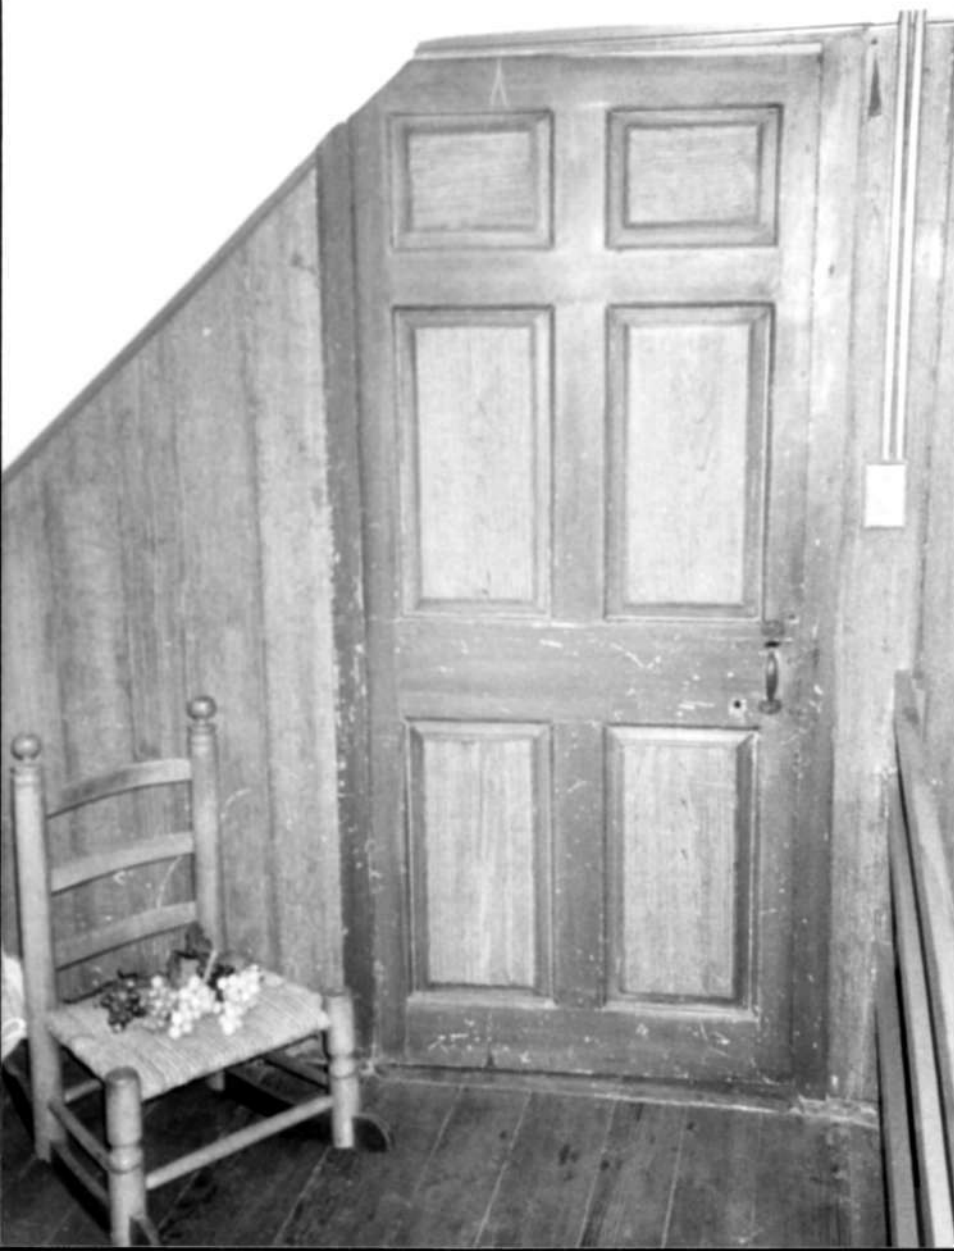
11g18

Main house, attic woodwork

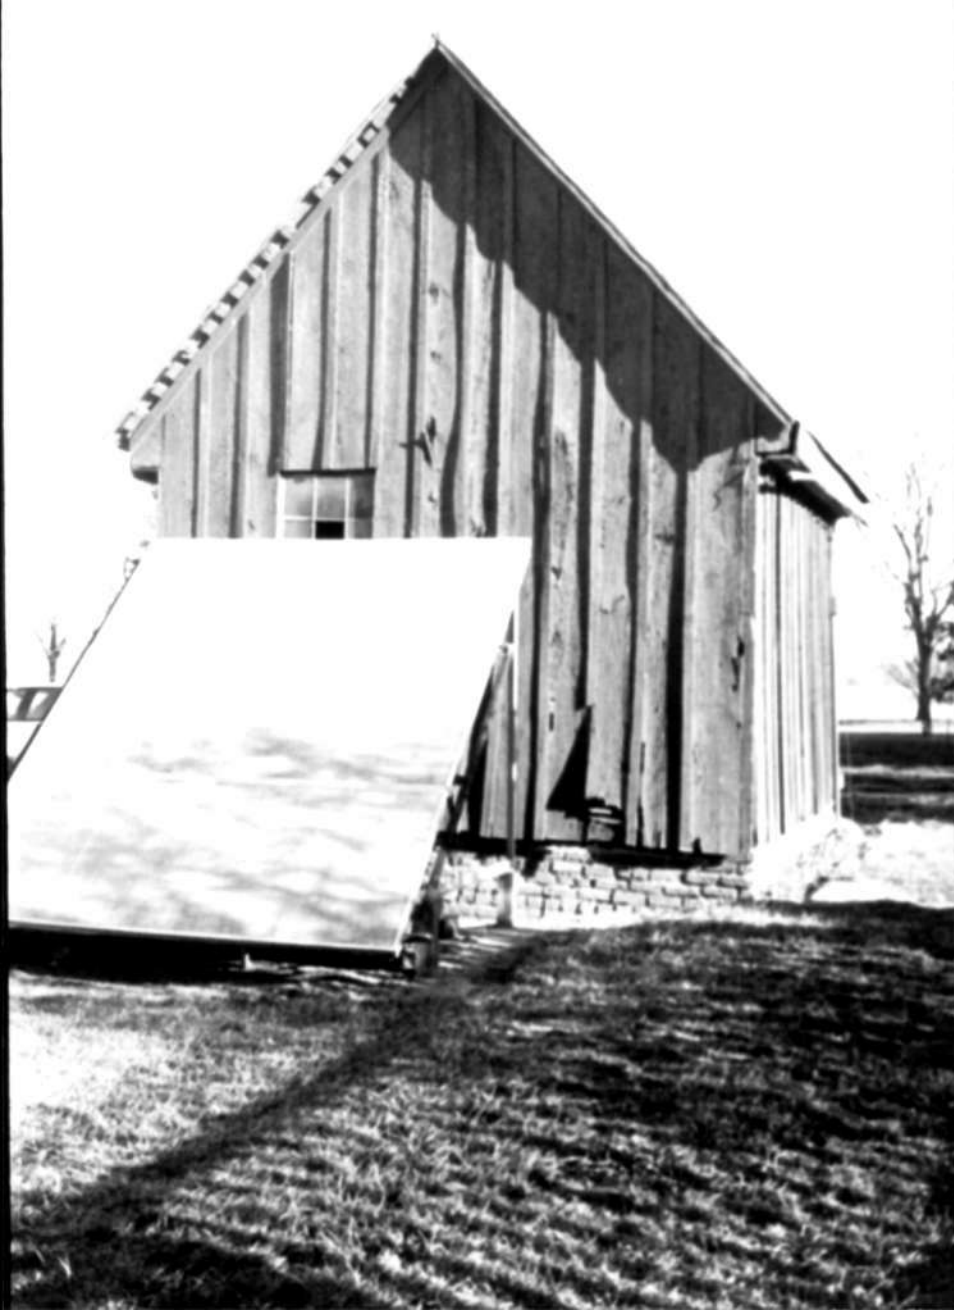
12g18

Smoke house, view to north

A "smoke house" (contributing) is located immediately south (about 34') and to the rear of the main dwelling's kitchen wing. This approximately 14 x 15' almost square wood frame building has board and batten siding and rests on a brick foundation. It has a metal roof.

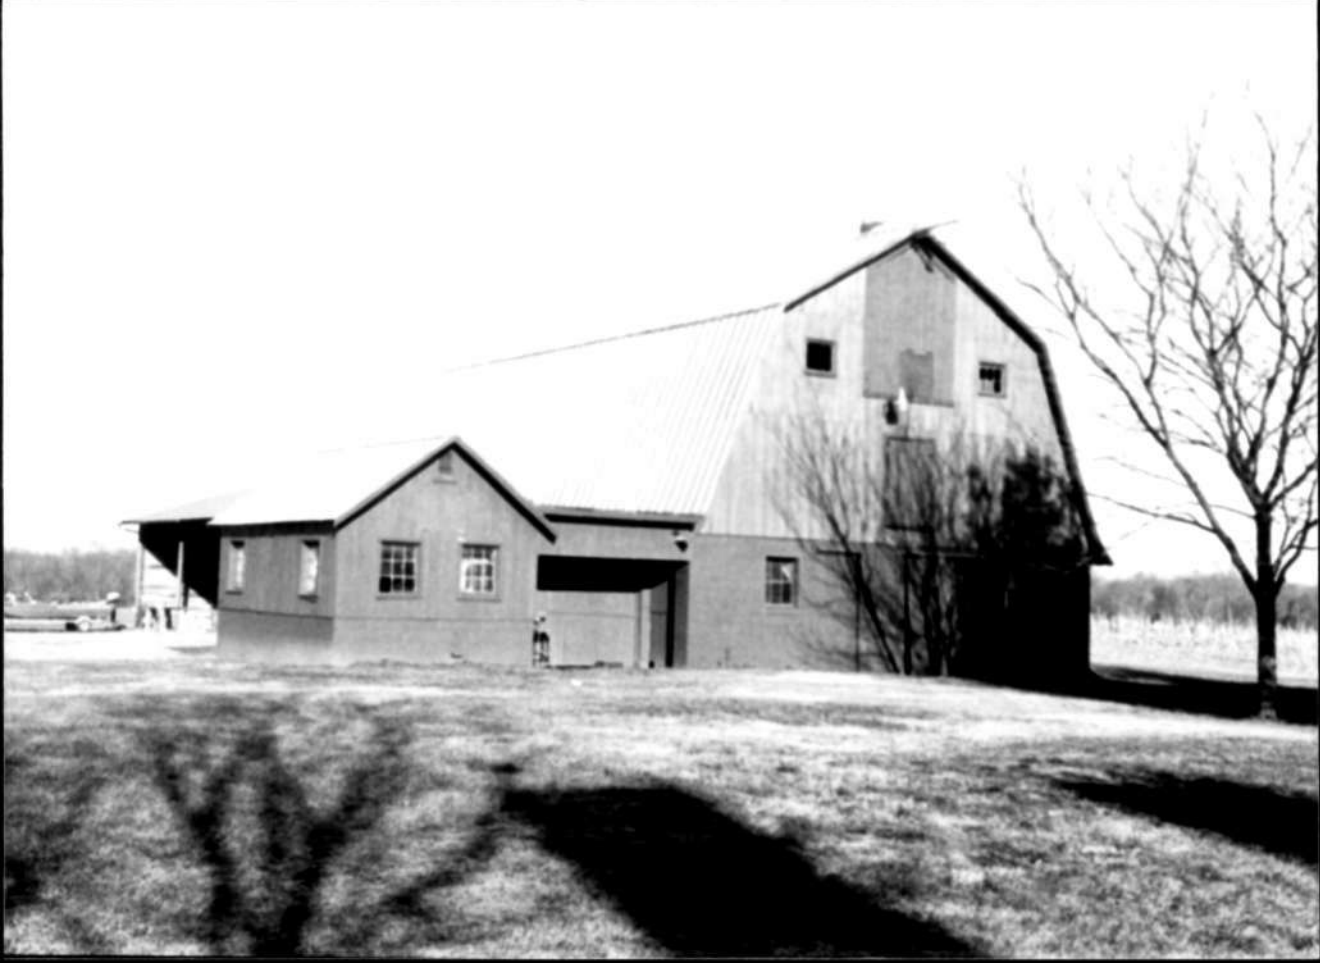
15 of 18

Dairy barn, silo & milkhouse, view
to west

Outbuildings: Three barns (contributing) are presently located on the property: a "dairy barn," an "animal barn," and a "granary." Constructed in the early twentieth century, the dairy barn (36 x 46') was used as part of the farm's dairy operation until the early 1980s. It has a cinder block foundation and a concrete first floor with milking stalls. The balloon framed building has a metal seamed roof and an attached shed (13 x 15'), silo (12' diameter) and milk house (12 x 19'). The building has not been used as a dairying operation since the early 1980s. A recently constructed (non contributing) pole barn (40 x 60') is located north of the dairy barn and is used for general equipment storage.

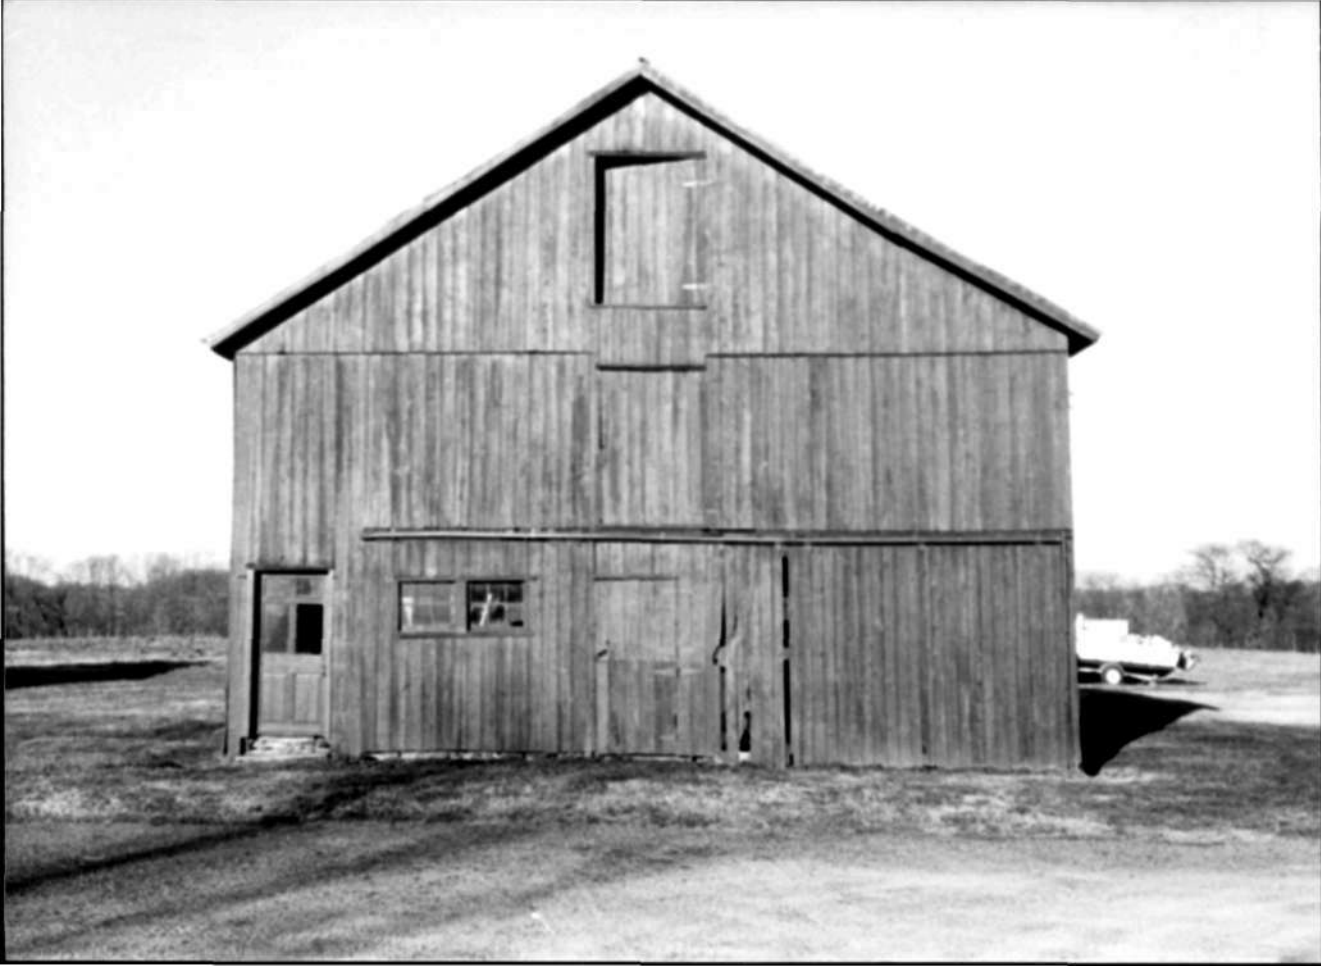
16g18

Animal barn, view to west

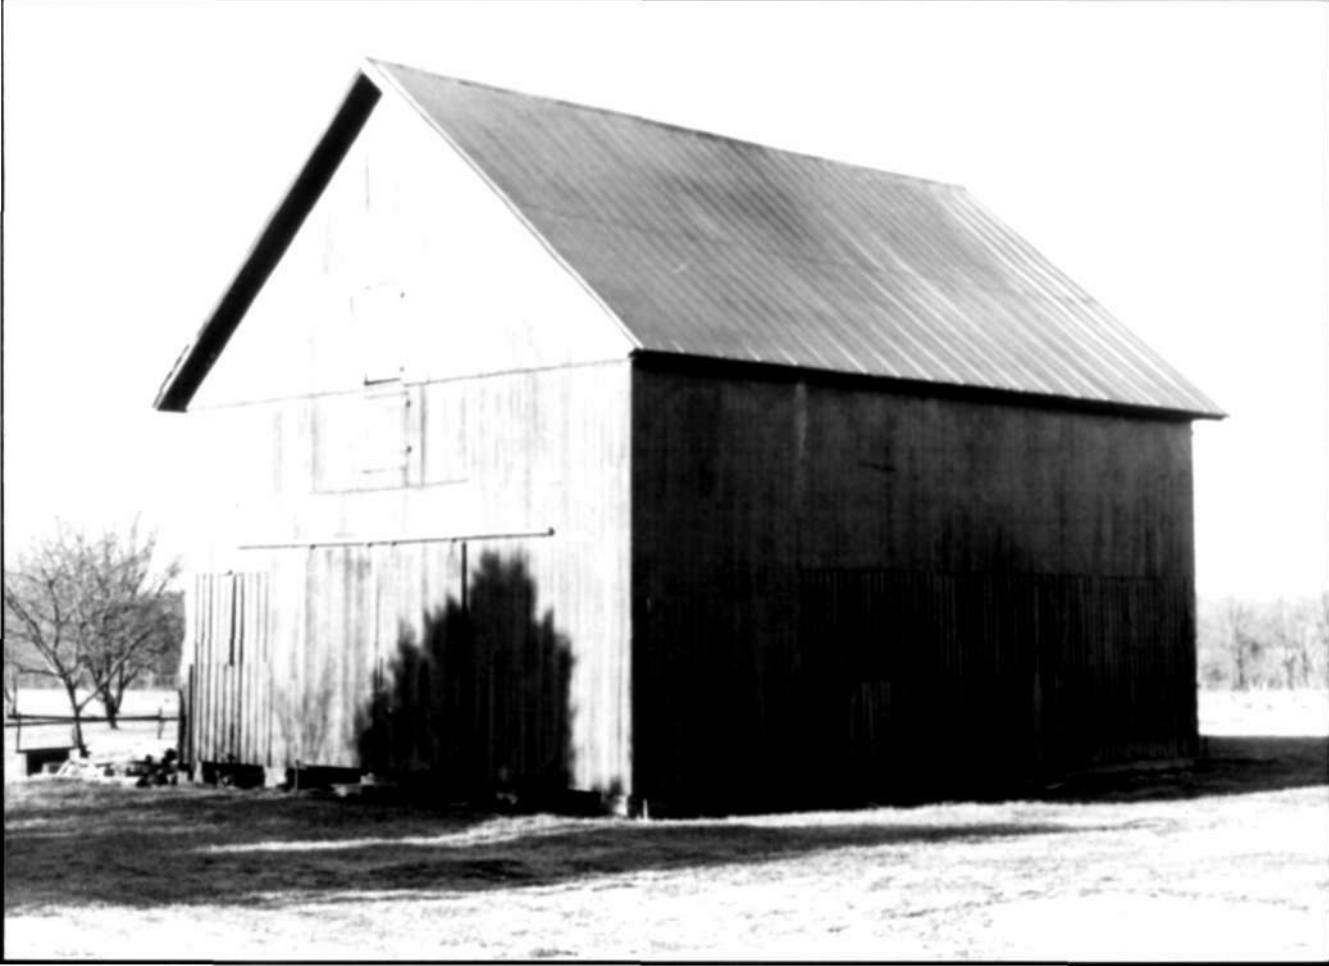
17g18

Granary, view to southwest

Located 50 feet south of the animal barn, the granary (28 x 36') dates to the second half of the nineteenth century. It retains portions of its original features to store a variety of grains, including cob corn bays on either side of the central carriage way. The building has a field stone foundation and a metal roof. Its general layout is similar to the Cochran Grange granary from Delaware, with a through passage on the lower level flanked by corn cob storage, a corner winder stairway, and an upper floor dedicated to small grain storage.³ The rear or western facade of the former hay barn, animal barn, and granary are aligned.

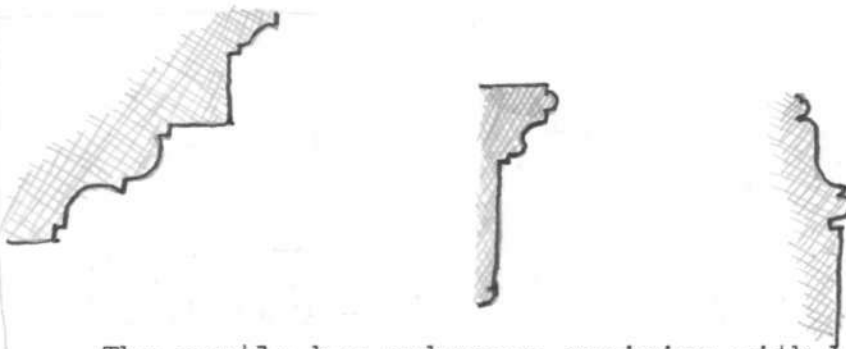
In the main, east parlor, the fireplace has a tabernacle overmantle. The mantle opening is rectangular with quarterround crossette surround. The straight mantle shelf has a curved bracket support. The room has crossette trim on the four windows and the door. Cornice, chairrail are sketched (not to scale) below.
